## Detailed Investigation for Leakage Detection and Flow Path Identification within an Embankment

# Groundwater Flow around a Tunnel Structure

## Groundwater Flow Investigation for the Design of a Ground Freezing System for a Tunnel Cross-Passage

# Investigation into the Cause of a Hydraulic Heave Failure at an excavation enclosure

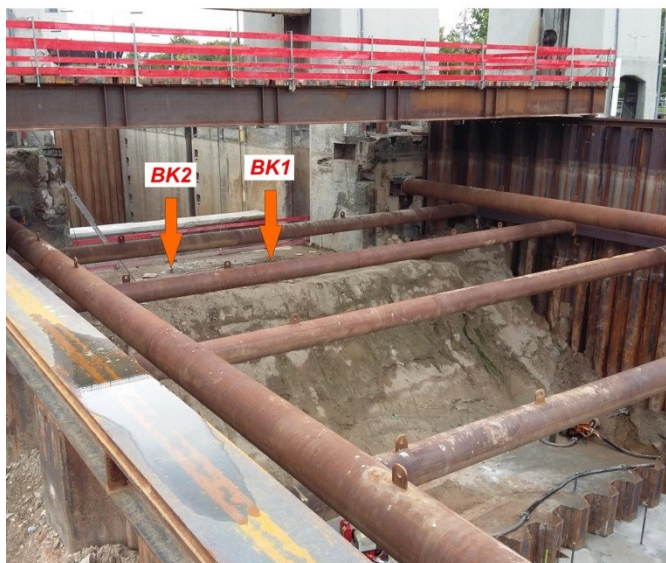
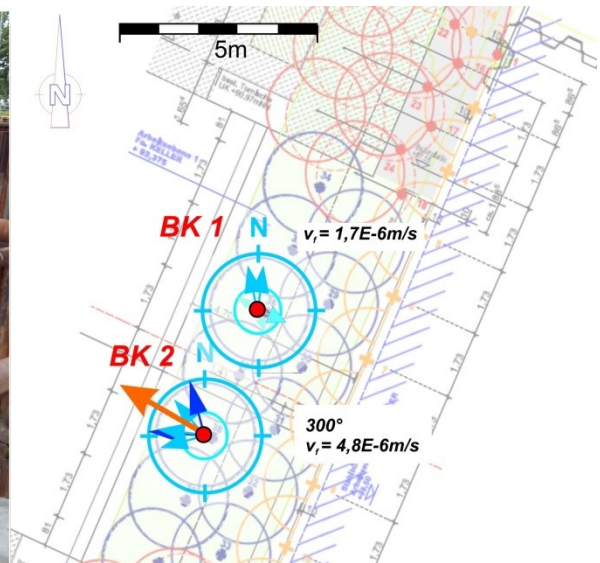
Horizontal in-situ groundwater flow measurements at five depths in each monitoring well showed that groundwater flow velocities within the depth interval relevant to the planned micropiles were low despite the high permeability of the surrounding sediments. The measured groundwater flow was predominantly directed parallel to the lock structure towards the downstream side. Based on the measured flow conditions, the risk of groundwater-induced washout of the fresh micropile concrete was assessed as low. The measurements therefore provided direct data for assessing the geotechnical risk and supporting quality assurance during micropile construction.
